**CWA COMPLIANCE EVALUATION INSPECTION REPORT
U.S. ENVIRONMENTAL PROTECTION AGENCY, REGION 5**

Purpose: Compliance Evaluation Inspection

Facility: Ex. 6 (Personal Privacy) Dairy Farms

Date of Inspection: November 21 – 22, 2019

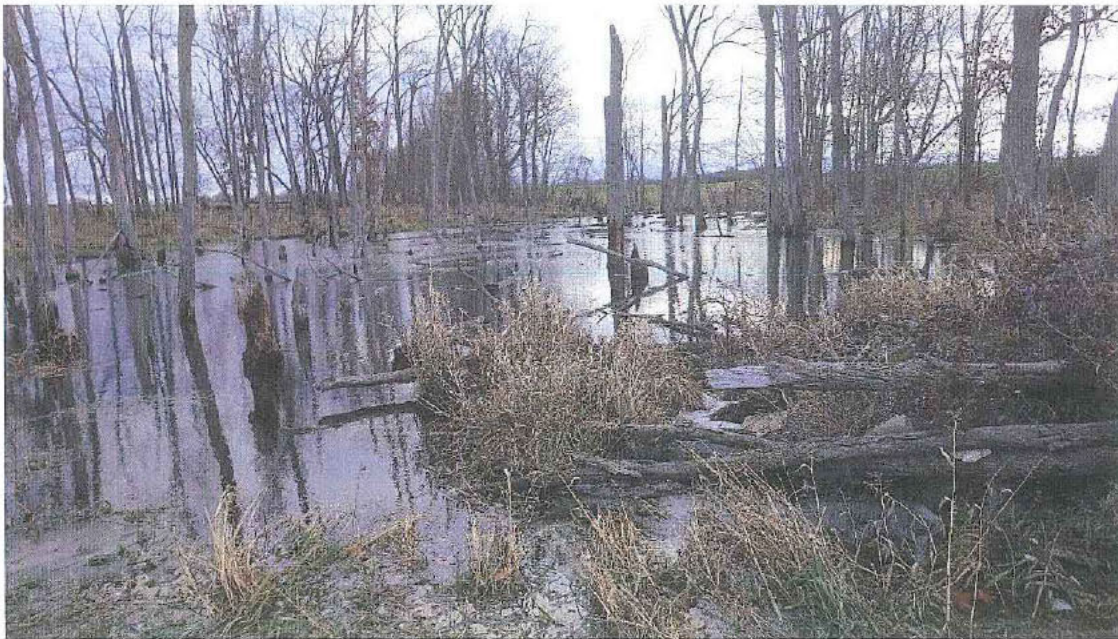
61: RIMG0061

Description: Wetland area in the southwest corner of the Field Ex. 6 (Personal Privacy) East.

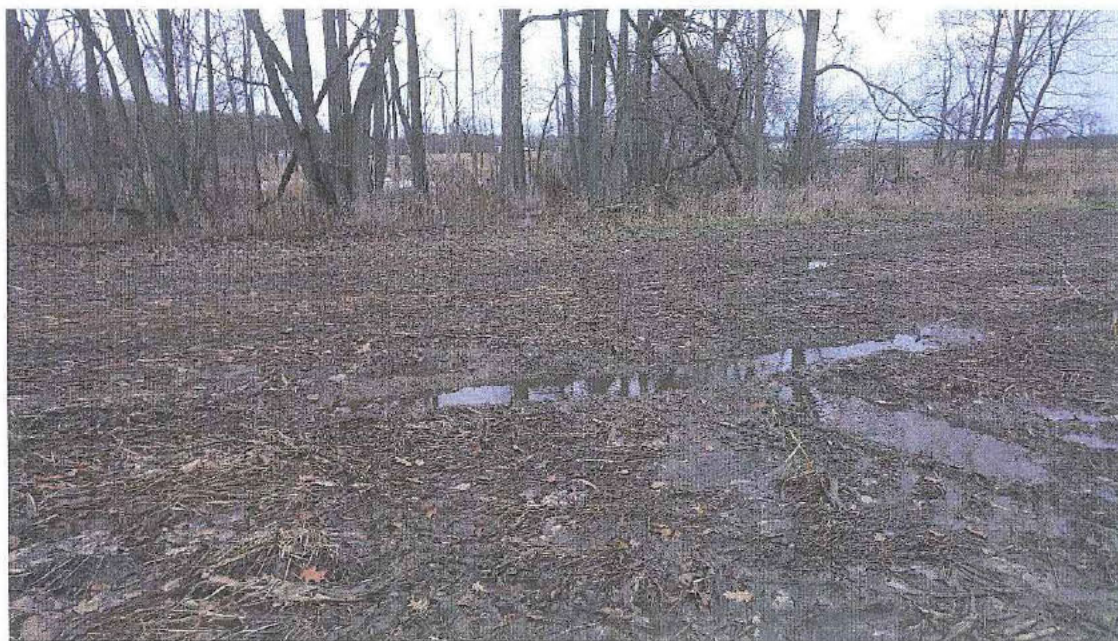
62: RIMG0062

EPA observed a truck hauling manure from the production area's Leachate Storage pond at approximately 10:30 am on November 21, 2019. Ex. 6 (Personal Privacy) (b) (6) stated that manure was being applied to Field Schauer East that morning. On November 22, 2019, at 10:20 am, manure on Field Schauer East was not yet incorporated.

Description: Description: Land application at Field Schauer East approximately 18-24 hours after application.

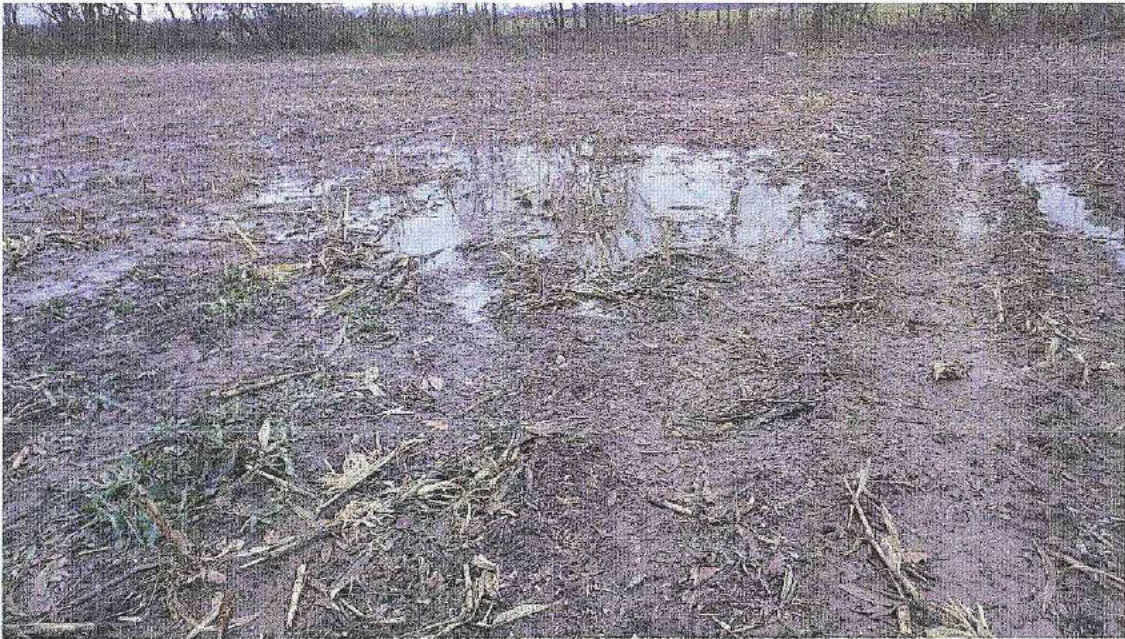
63: RIMG0063

Description: Land application at Field Ex. 6 (Personal Privacy) East approximately 18-24 hours after application.

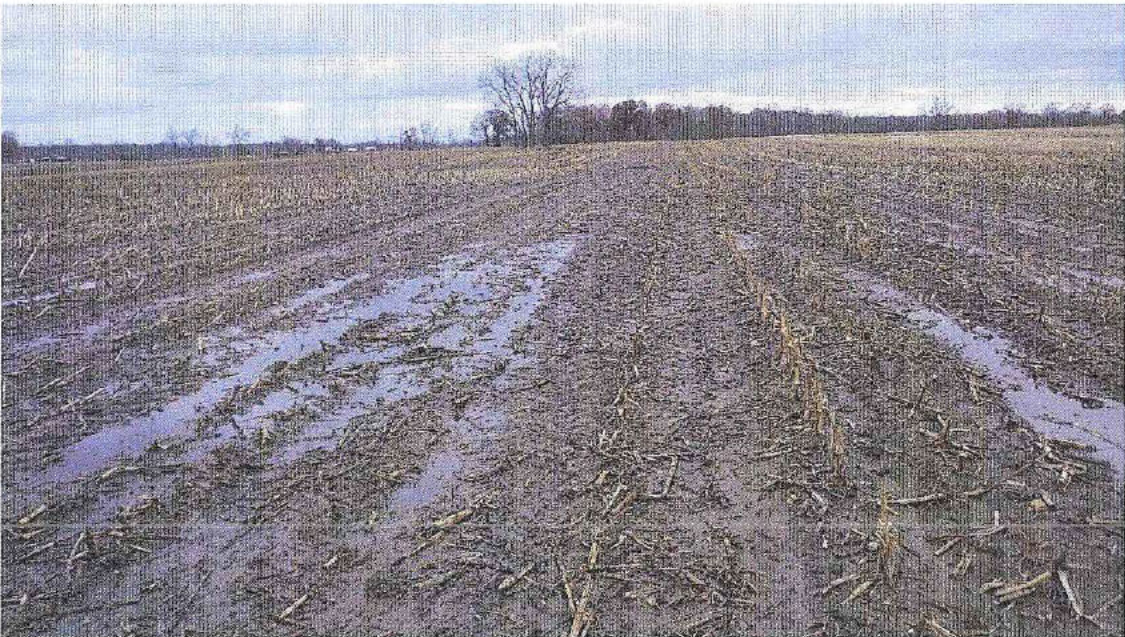
64: RIMG0064

Description: Land application at Field Ex. 6 (Personal Privacy) East approximately 18-24 hours after application.

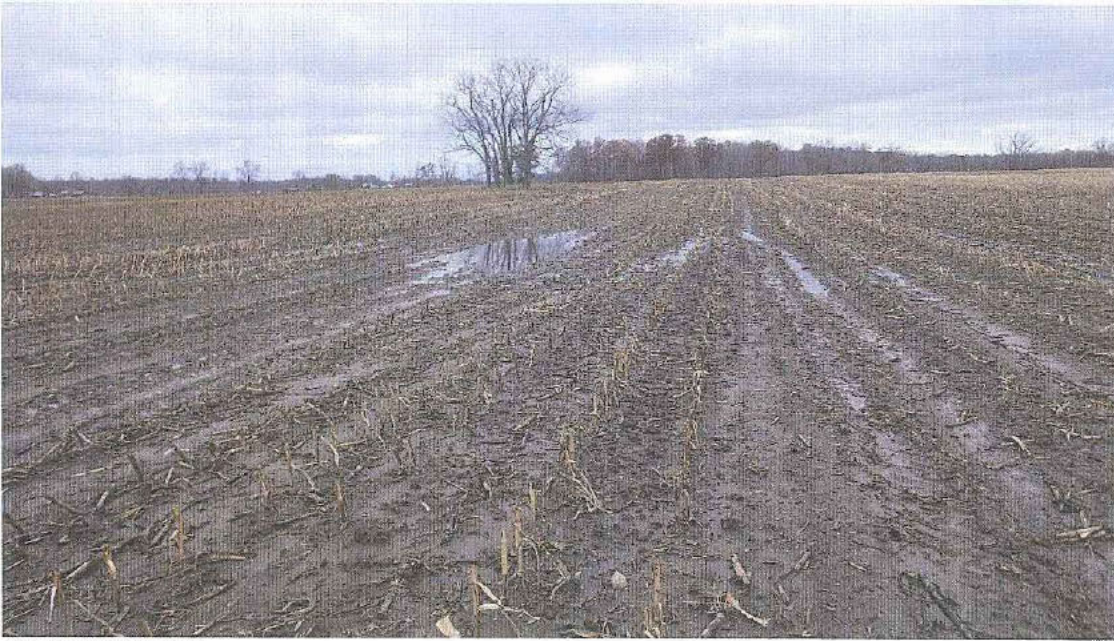
65: RIMG0065

Description: Land application at Field [REDACTED] East approximately 18-24 hours after application.

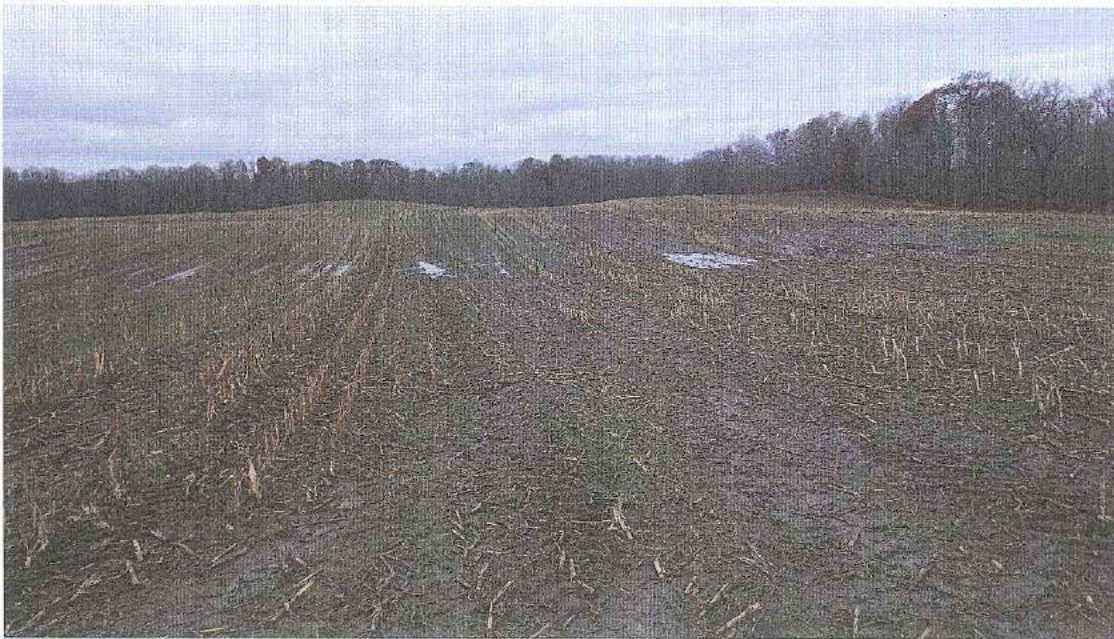
66: RIMG0066

Description: Land application field at Field [REDACTED] West, located southwest of the intersection of Defay Road and Meridian Road. Manure was last applied on November 8, 2019.

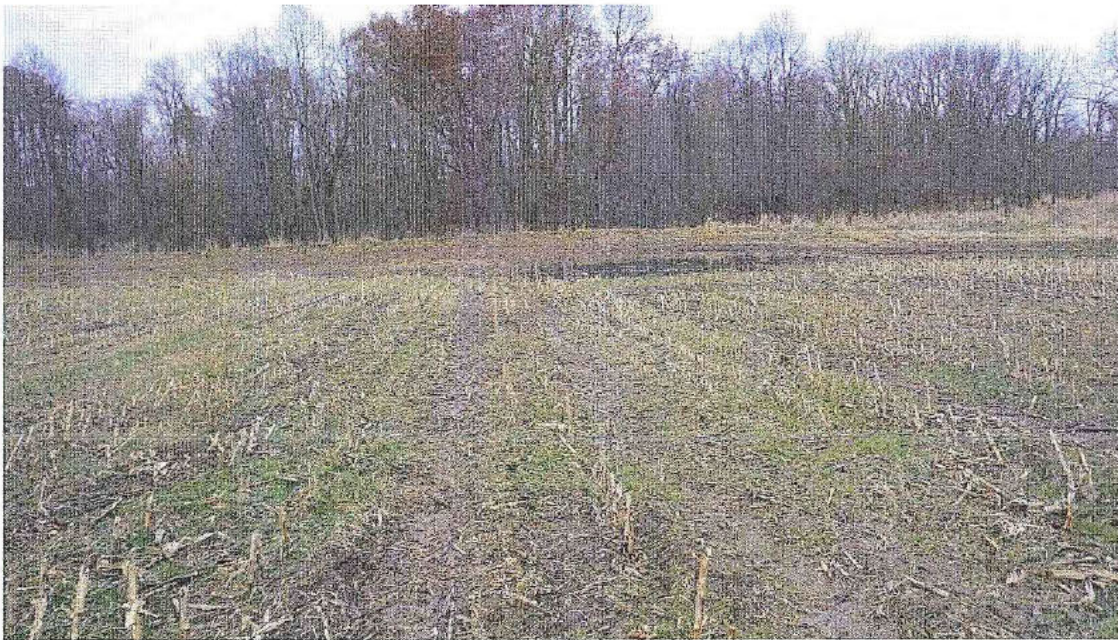
67: RIMG0067

Description: Land application at Field Ex. 6 (Personal Privacy) West. Manure was last applied on November 8, 2019.

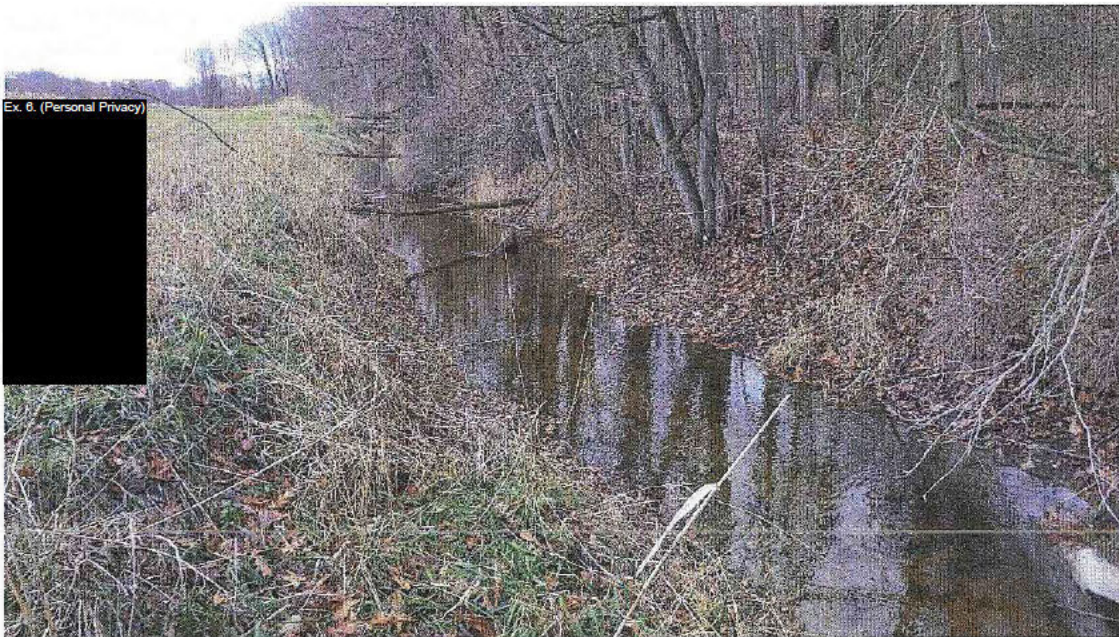
68: RIMG0068

Description: Stream along west edge of the Field Ex. 6 (Personal Privacy) West.

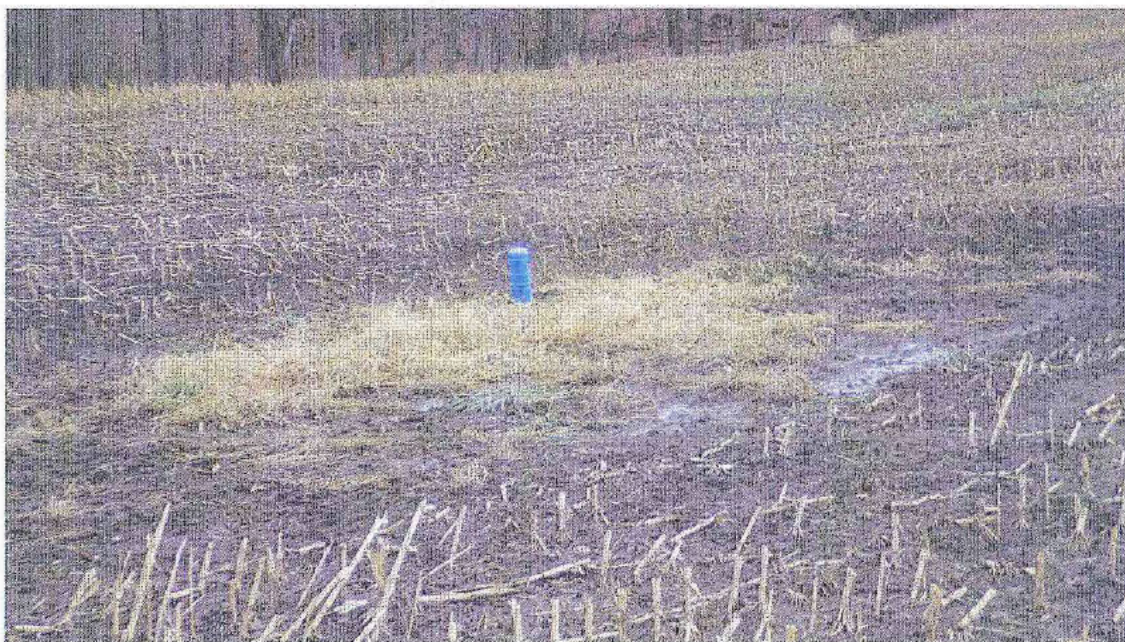
71: RIMG0071

At approximately 9:20 am we walked across the Meridian Highway to Field Schauer West. According to Ex. 6. (Personal Privacy) manure was last applied to this field on November 8, 2019. We observed a tile riser on the north side of the field in a depressed area with some water pooling around it but no visible flow into it (photo 71). On the west edge of the field we observed a stream (Kempton Drain) flowing south to Fisk Drain then to Bean Creek. There was pooling water on the field approximately 30 feet from Kempton Drain. However, we did not observe any flow towards the stream at the time of the inspection. We left Field Schauer West at 10:20 am and called Ex. 6. (Personal Privacy) to let him know.

Description: Field tile surface inlet located on the northern side of Field Ex. 6 (Personal Privacy) West.
